### Applicability

This document applies to the part numbers of STM32L471xx devices and the device variants as stated in this page.

It gives a summary and a description of the device errata, with respect to the device datasheet and reference manual RM0351.

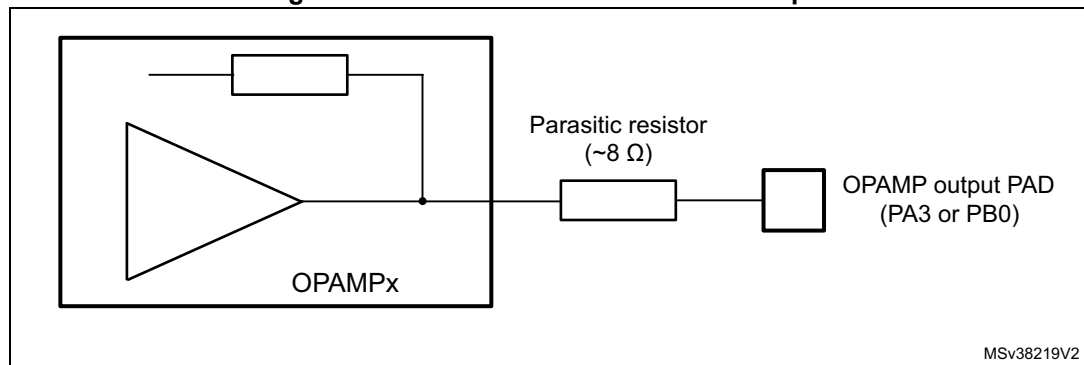
Figure 3. Parasitic resistor on OPAMP output

Resistor value between OPAMP outputs and I/O ( PA3 or PB0 ) is greater than expected: 8 Ω typical, as shown in [Figure 3](#). As a consequence the OPAMP characteristics can be impacted depending on the current sunk on the output.
