Device **TC26x**
Marking/Step **ES-BC, BC**
Package **see Data Sheet**

10314AERRA

This Errata Sheet describes the deviations from the current user documentation.

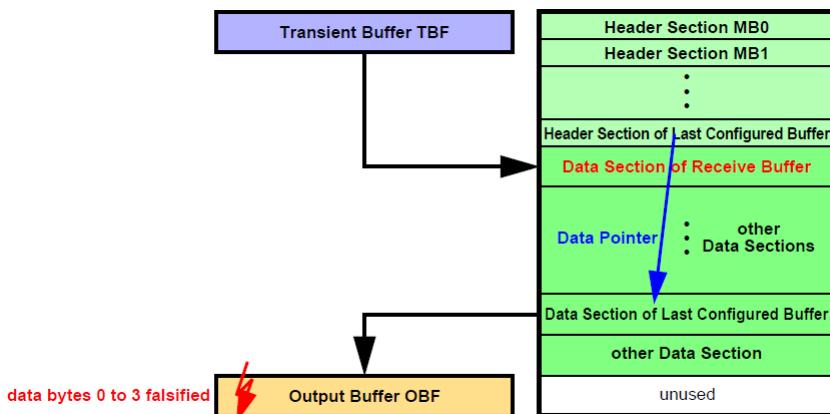
Figure 1 Message buffer transfer from Message RAM to OBF

When the message buffer has its payload configured to maximum length (**PLC = 127**), the OBF word on address 00h (payload data bytes 0 to 3) is overwritten with unexpected data at the end of the transfer.

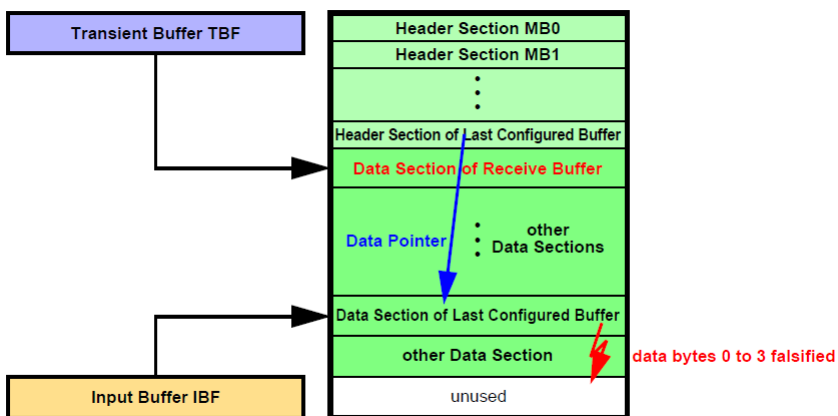
Figure 2 Message buffer transfer from IBF to Message RAM

After the Data Section of the selected message buffer in the Message RAM has been written, one additional write access overwrites the following word in the Message RAM which might be the first word of the next Data Section.

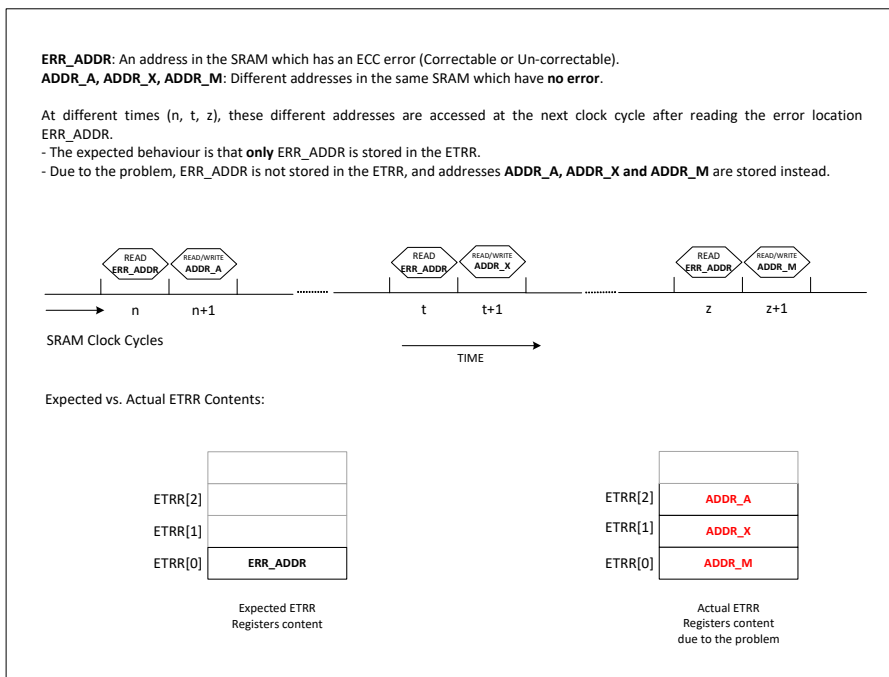
Figure 4 Example sequence showing how registers ETRRx may be filled with “Error Free” addresses

When such a consecutive access sequence (read from ERR_ADDR followed by read/write of different address(es)) happens multiple times, registers ETRRx are filled with addresses that have actually no error – and the SRAM address which actually has an error is not stored indeed. **Figure 4** shows such an example scenario.

The consequence of the scenario explained in **Figure 4** is that a single error in the SRAM – example just one correctable error at a location ERR_ADDR – can result in registers ETRRx getting filled with fault-free address, and thus potentially even triggering an ETRR overflow.

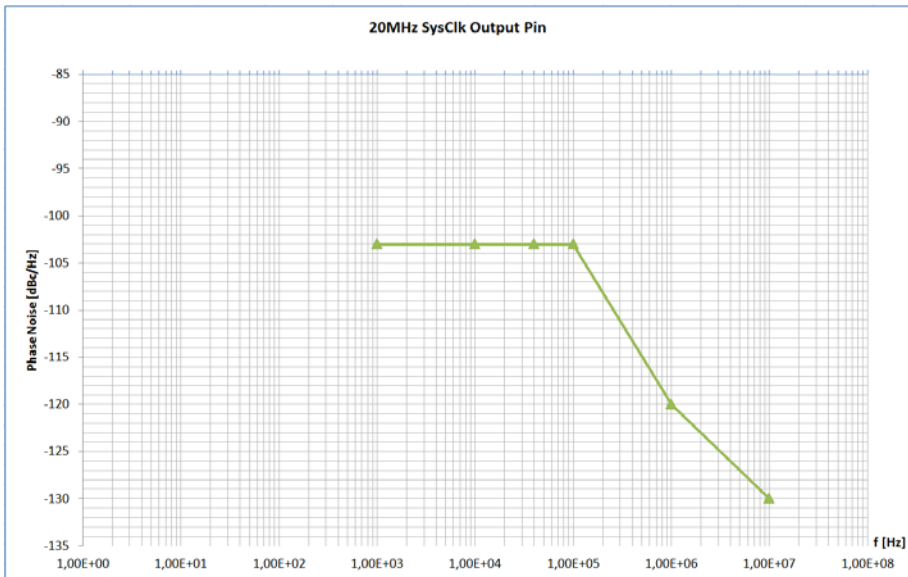
Figure 8 Phase Noise Density on SysClk Output Pin

Consistently, measurements on the HSSL/HSCT communication channel using the SysClk signal with I_{PN} from above show that the ultimate target of $BER_{20} = 10^{-12}$ is met. In such a measurement setup, both the master and the slave are microcontrollers of the AURIX™ family.

The diagram below shows the phase noise density on the SysClk pin when no application pattern but only the HSSL/HSCT subsystem is running:

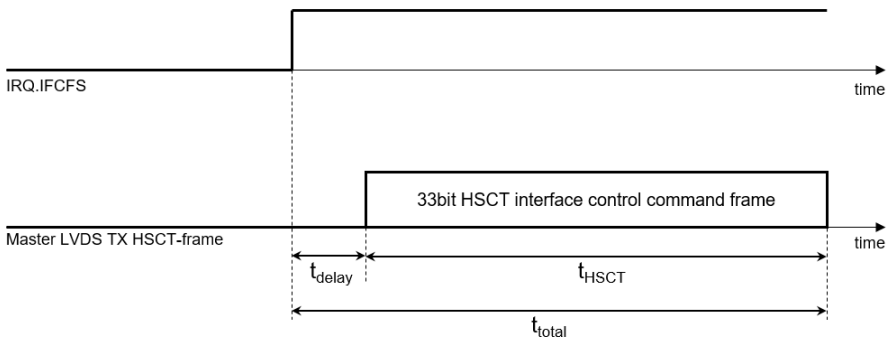
Figure 9 Timing of LVDS TX interface command sending in relation to IRQ.IFCFS

the user might falsely assume that also the actual sending on the LVDS TX port has already occurred once the IRQ.IFCFS flag is set, which is not true.

Instead the timing shown in **Figure 9** applies.

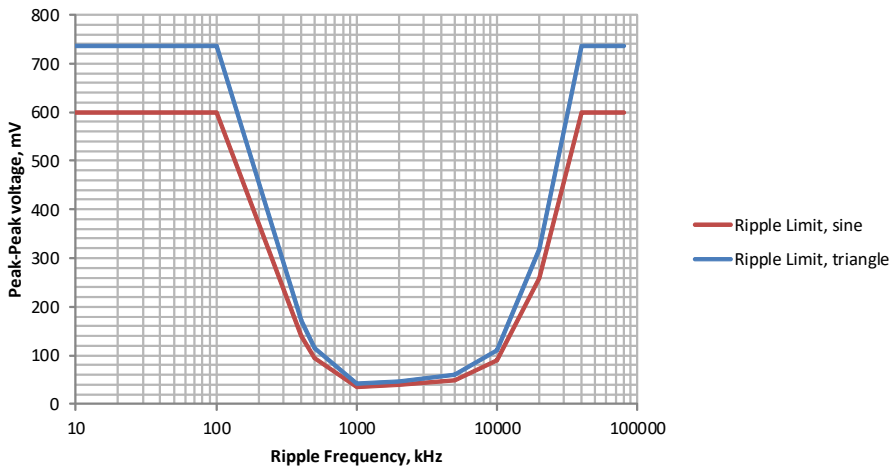
Figure 17 Ripple Voltage vs. Frequency Characteristic

The internal back-up clock is sensitive to specific power supply voltage disturbance/ripple caused by a voltage ripple intrinsic to DC-DC converters. Specific conditions such as insufficient filtering of the ripple may lead to improper behavior of the start-up scheme of the back-up clock, and thus stuck-at state during the start-up of the microcontroller until this condition is removed.

The diagram reflects acceptable ripple level during the cold start of the microcontroller at the respective VDDP3/VEXT/VEVRSB supply of the PMS subsystem, depending on the device and package type, as shown in the following table.

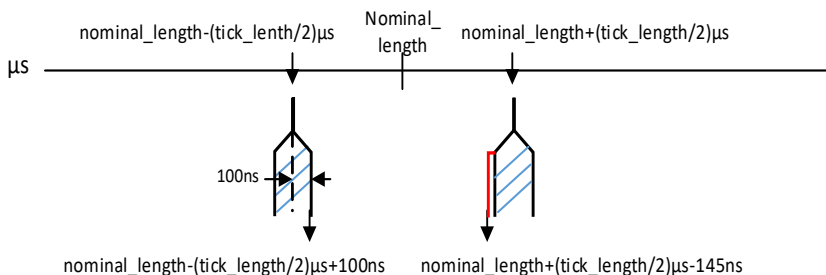
Figure 19 SENT Tolerance of this Design Step

In this design step the range is delimited as follows:

- The lower border is $\text{nominal_value} - (\text{tick_length}/2) \mu\text{s} + 100 \text{ ns}$
- The upper border is $\text{nominal_value} + (\text{tick_length}/2) \mu\text{s} - 145 \text{ ns}$.

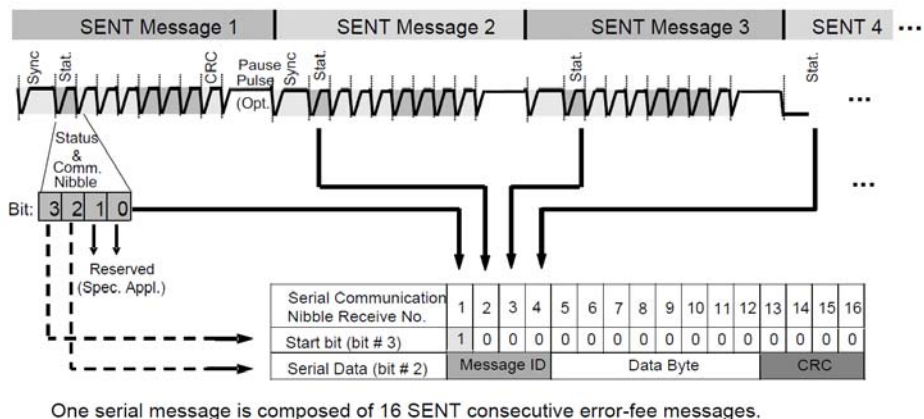
Figure 20 Short Serial Message, Serial Data Encoding over 16 messages

Figure 20 shows a corrected version of this figure.
