Product Change Notification		Date April 7, 2021
Product	Digi Rabbit RCM3xxx/RCM4110 (29 MHz)

Description of change	<p>Due to the obsolescence of the previously qualified 45ns flash memory for select SKUs in the Rabbit family's product line, Digi has qualified 55ns flash from the same supplier. Digi has qualified Microchip SST39LF020-55-4C-WHE to replace Microchip SST39LF020-45-4C-WH , qualified Microchip SST39LF040-55-4C-WHE-ND to replace SST39LF040-45-4C-WH.</p> <p>Although the flash change is backward compatible with existing customer software, Digi recommends making changes to Dynamic C 9 (Rabbit 2000 and 3000 based products) or 10 (RCM4110) to improve timing margins during BIOS startup. Please visit the following links for details:</p> <p>Dynamic C 9: https://github.com/digidotcom/DCRabbit_9/issues/7 Dynamic C 10: https://github.com/digidotcom/DCRabbit_10/issues/29</p> <p>Please refer to the attached label to identify the effective revision change.</p>
------------------------------	--

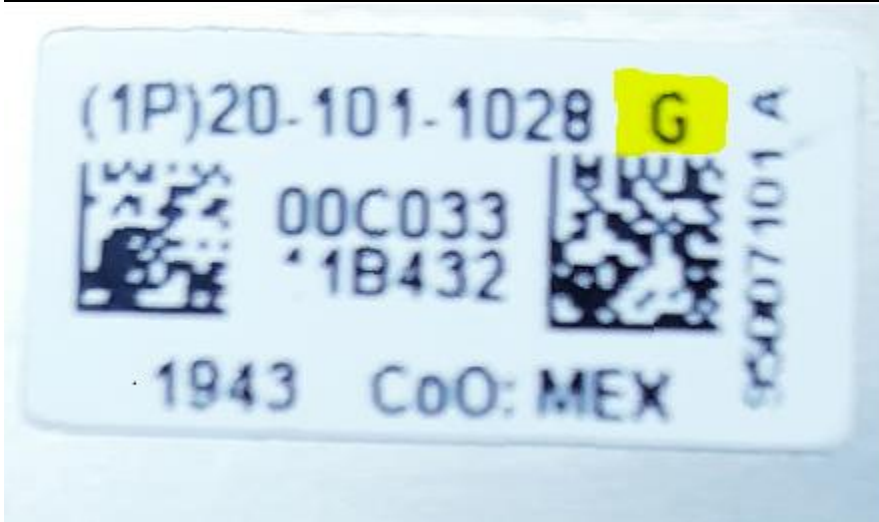
Part number	Description	New Revision level *See attachment for location
20-101-0507	RCM3000	F
20-101-0508	RCM3010	F
20-101-0517	RCM3100	D
20-101-0518	RCM3110	D
20-101-0561	RCM3400	D
20-101-1093	RCM4110	F
