**Device**            **TC27x**  
**Marking/Step**   **ES-DC, DC**  
**Package**           **see Data Sheet**

## 10216AERRA

This Errata Sheet describes the deviations from the current user documentation.

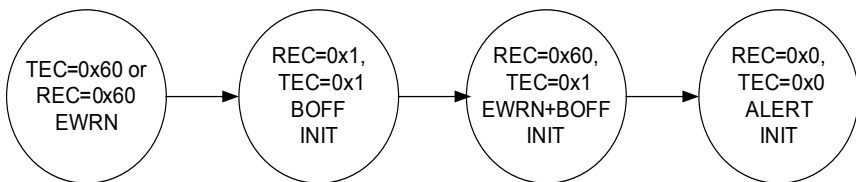
**Figure 10 Alert Interrupt Behavior in case of Bus-Off**

When the threshold for error warning (EWRN) is reached (default value of Error Warning Level EWRN = 0x60), then the EWRN interrupt is issued. The bus-off (BOFF) status is reached if TEC > 255 according to CAN specification, changing the MultiCAN module with REC and TEC to the same value 0x1, setting the INIT bit to 1<sub>B</sub>, and issuing the BOFF interrupt. The bus-off recovery phase starts automatically. Every time an idle time is seen, REC is incremented. If REC = 0x60, a combined status EWRN+BOFF is reached. The corresponding interrupt can also be seen as a pre-warning interrupt, that the bus-off recovery phase will be finished soon. When the bus-off recovery phase has finished (128 times idle time have been seen on the bus), EWRN and BOFF are cleared, the ALERT interrupt bit is set and the INIT bit is still set.

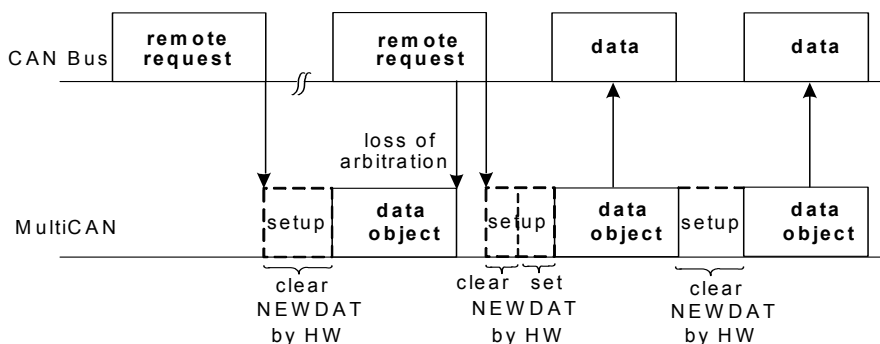
**Figure 11 Loss of Arbitration**

When the appropriate message object (data frame) triggered by the first remote frame wins the arbitration, it will be sent out and  $NEWDAT$  is not reset. This leads to an additional data frame, that will be sent by this message object (clearing  $NEWDAT$ ).

There will, however, not be more data frames than there are corresponding remote requests.

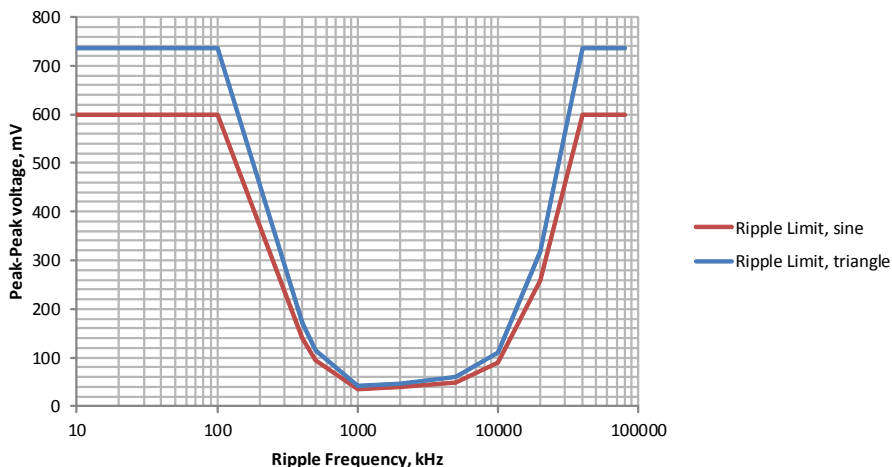
**Figure 14 Ripple Voltage vs. Frequency Characteristic**

The internal back-up clock is sensitive to specific power supply voltage disturbance/ripple caused by a voltage ripple intrinsic to DC-DC converters. Specific conditions such as insufficient filtering of the ripple may lead to improper behavior of the start-up scheme of the back-up clock, and thus stuck-at state during the start-up of the microcontroller until this condition is removed.

The diagram reflects acceptable ripple level during the cold start of the microcontroller at the respective VDDP3/VEXT/VEVRSB supply of the PMS subsystem, depending on the device and package type, as shown in the following table.

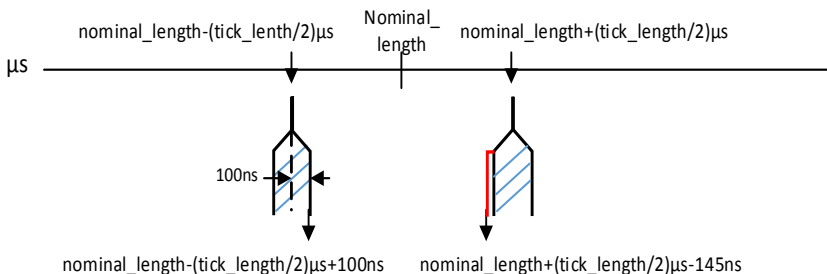
**Figure 16 SENT Tolerance of this Design Step**

- The lower border is  $\text{nominal\_value} - (\text{tick\_length}/2) \mu\text{s} + 100 \text{ ns}$
- The upper border is  $\text{nominal\_value} + (\text{tick\_length}/2) \mu\text{s} - 145 \text{ ns}$ .
