Errata  
**MSP430FG439 Microcontroller**

This document describes the known exceptions to the functional specifications (advisories).

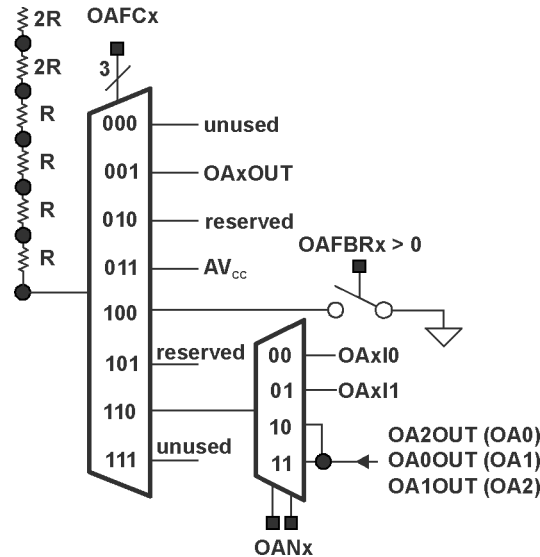
## OA1

**Function** OAxI1 input selection

**Description** Referring to the OA block diagram in the MSP430x4xx User's Guide, the internal connection of the OAxI1 input to the OAFcX mux is incorrect. The signal input to the OAFcX mux when OANx = 01 is OA0I1 for all OAs. See the figure below for a graphical representation.

**Workaround** None

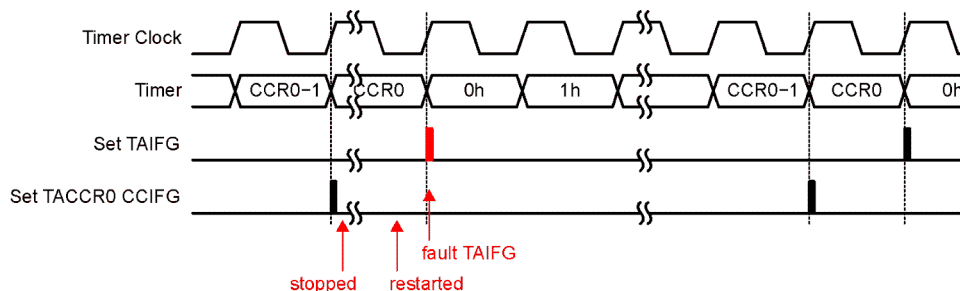
**TA21** *TA Module*

**Function** TAIFG Flag is erroneously set after Timer A restarts in Up Mode

**Description** In Up Mode, the TAIFG flag should only be set when the timer counts from TACCR0 to zero. However, if the Timer A is stopped at TAR = TACCR0, then cleared (TAR=0) by setting the TACL bit, and finally restarted in Up Mode, the next rising edge of the TACLK will erroneously set the TAIFG flag.

**Workaround** None.

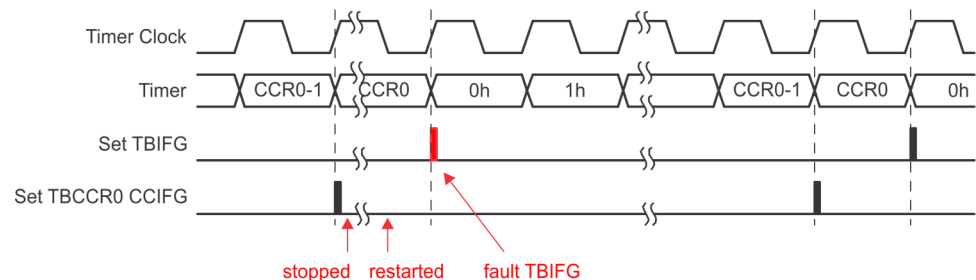
## TB24 *TB Module*

**Function** TBIFG Flag is erroneously set after Timer B restarts in Up Mode

**Description** In Up Mode, the TBIFG flag should only be set when the timer resets from TBCCR0 to zero. However, if the Timer B is stopped at  $TBR = TBCCR0$ , then cleared ( $TBR=0$ ) by setting the TBCLR bit, and finally restarted in Up Mode, the next rising edge of the TBCLK will erroneously set the TBIFG flag.

**Workaround** None.
