APPLICATION NOTE 3479

# DS2154 – Migrating from Revision A2 to D1

Mar 23, 2005

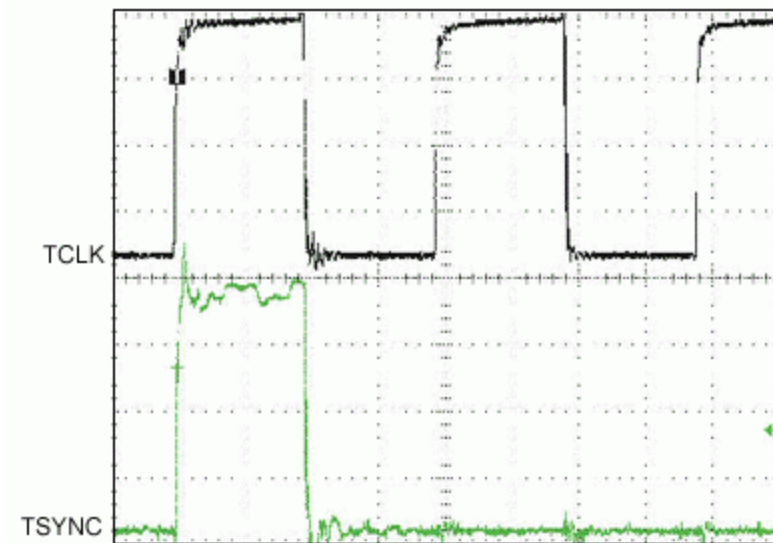
Figure 4. Transmit-side timing between TSYNC and TCLK taken from an oscilloscope.

In the DS2154 D1 revision, when TSYNC is configured as an input by setting TCR1.0 = 0 (TSIO = 0), the E1 SYNC signal sometimes does not synchronize correctly with the MSB of time slot 0 (TS0).

**Figure 4** is the scope image of a possible valid timing diagram between TSYNC and TCLK for the DS2154 A2 revision. However, this is not valid for the DS2154 D1 revision.

Figure 4 shows the falling edge of TCLK and TSYNC as being nearly simultaneous. In the D1 revision, the incoming TSYNC is sampled at the falling edge of TCLK. In order to get the correct sampling, the user needs to add 25ns or more delay onto TSYNC. The user can also make the clock pulse of TSYNC wider. This way, the user can solve the sampling problem. The A2 revision of the DS2154 has a rising edge detector to aid in aligning TSYNC with TS0. The D1 revision of the DS2154 simply samples TSYNC with the falling edge of TCLK. **Figure 5** shows the timing diagram between TCLK and TSYNC after making the TSYNC pulse wider.

When replacing the A2 revision of the DS2154 with the D1 revision, most applications will never experience this timing issue. However, if the application experiences this problem, it is recommended to increase the TSYNC delay by 25ns or to widen the TSYNC pulse. For further questions about the operation of the DS2154, please contact the Maxim Telecommunications Applications support team through email: [telecom.support@maximintegrated.com](mailto:telecom.support@maximintegrated.com), or phone: 972-371-6555.
