3 Volt Intel® Advanced+ Boot Block Flash Memory

28F800C3, 28F160C3, 28F320C3, 28F640C3

Specification Update

Order Number: 297938-014

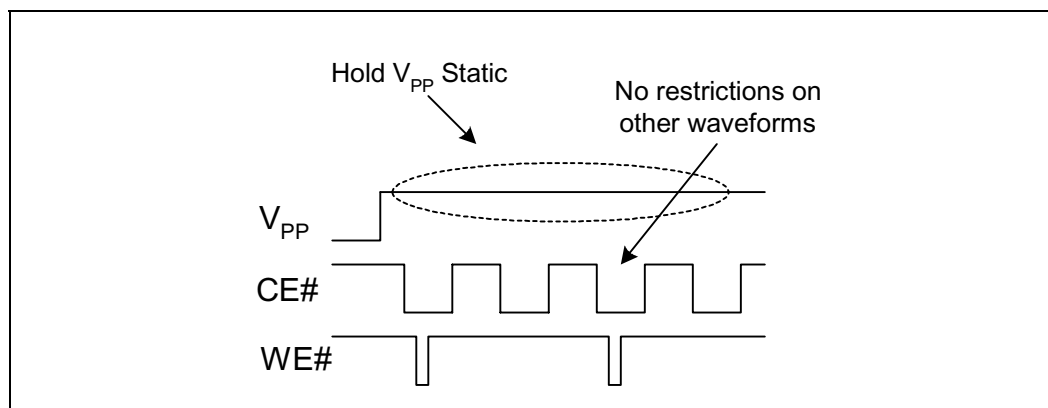
Problem: The 0.18µm 28F320C3xC devices can unintentionally reset under certain conditions where V_{PP} toggles.

Implication: When the reset occurs, any command being executed is interrupted and the flash switches to read array mode.

3) Set V_{PP} to a static high or static low level as shown here; and

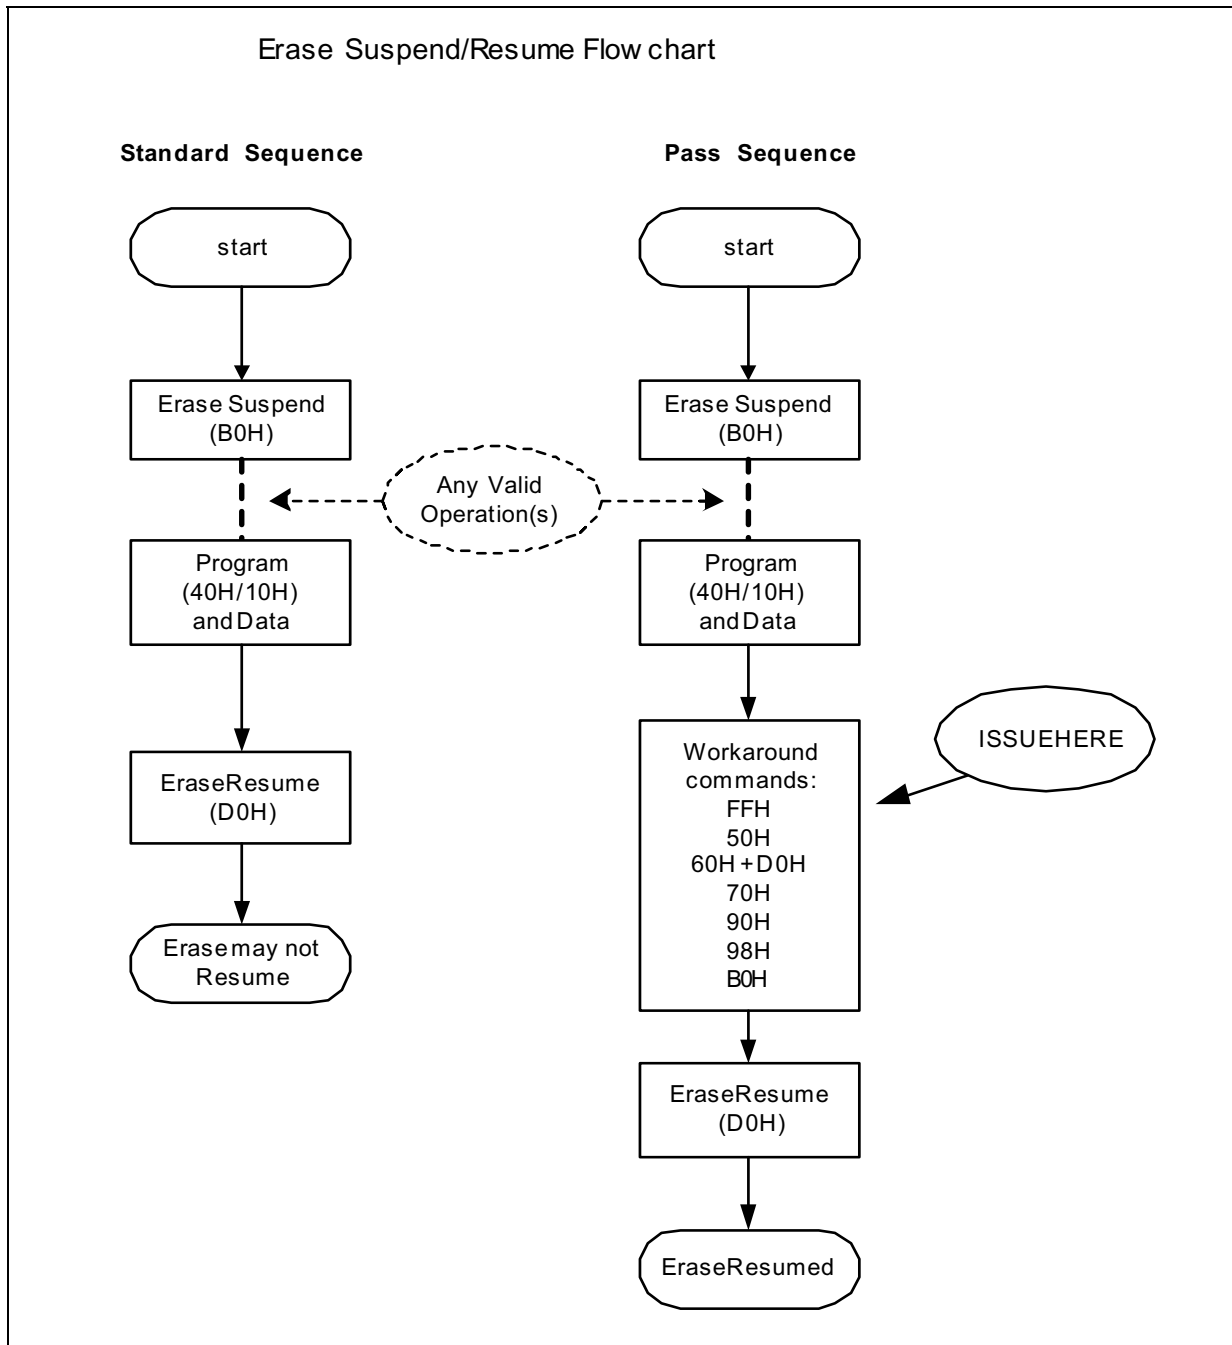
Figure 1. Workaround Placement

Problem: On the 0.18µm 28F160C3xC devices, a design anomaly was discovered. During an Erase-Suspend operation, if the Program (40H/10H) sequence is executed, under limited conditions the proceeding Erase Resume command (D0H) may not actually resume the device. No customers have reported failures in product applications. Customers who use any version of FDI (Intel Flash Data Integrator) software will not see this issue. If the Read Array command is issued prior to the Erase Resume command, users will not see the issue (typical in XIP applications).

Implication: The Resume Command (D0H) may be ignored by the device and will not correctly resume. The device will appear to remain in suspend (via status register). After a reset of the flash device the status register will clear. This failure has been recreated in a lab environment only.

2. During an Erase-Suspend (B0H), user must issue any of the following commands after issuing the Program (40H/10H) and data sequence but before issuing the Erase-Resume (D0H) command.

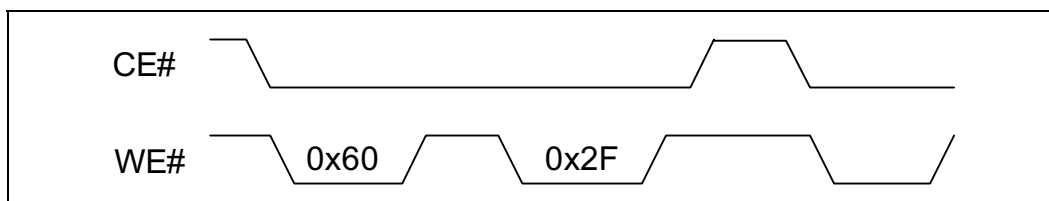
Problem: On the 16Mb and 64Mb 0.18μm devices, if CE# is deasserted after any block lock operation and before the next write sequence, the part may perform the same operation on additional blocks. (See waveform below.)

Implication: When CE# is deasserted after performing a block lock operation to a specific block and prior to the next write sequence, other blocks may perform the same operation.
