Device **TC26x**
Marking/Step **ES-BC, BC**
Package **see Data Sheet**

10314AERRA

This Errata Sheet describes the deviations from the current user documentation.

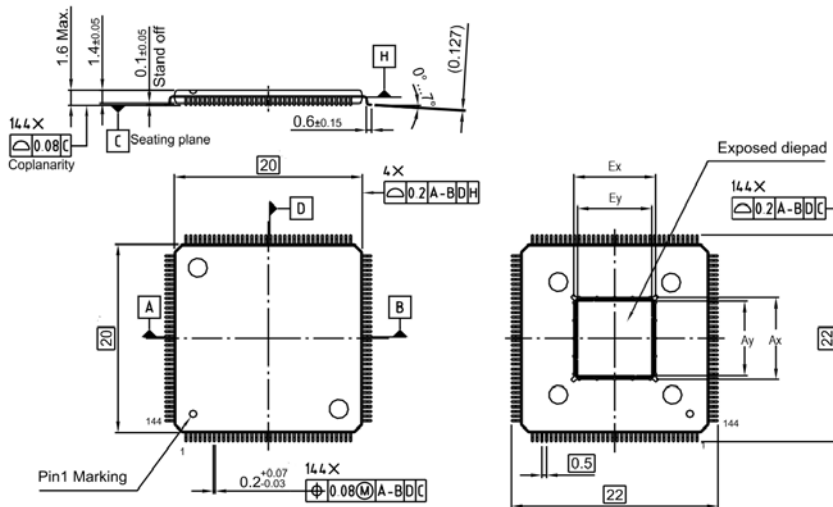
Figure 15 Package Outlines LQFP-144 for TC26x

Note: For the exposed diepad of the LQFP-144 package of the TC26x, structural corner protrusions have to be considered for purposes of system design and integration with a maximum boundary of 8.0 mm for TC26x devices with feature package D and DC (square Epad), and of 8.9 mm (in x direction) and 9.5 mm (in y direction) for TC26x devices with feature package DA.

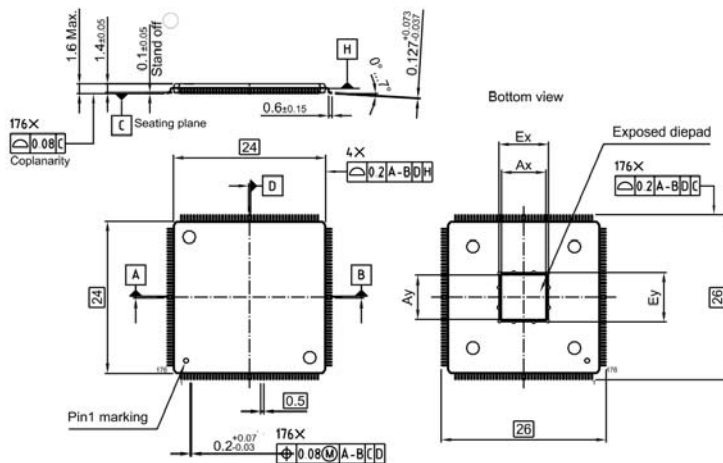
Figure 16 Package Outlines LQFP-176 for TC26x

Note: For the exposed diepad of the LQFP-176 package of the TC26x, structural corner protrusions have to be considered for purposes of system design and integration with a maximum boundary of 8.0 mm for TC26x devices with feature package D and DC (square Epad), and of 8.9 mm (in x direction) and 9.5 mm (in y direction) for TC26x devices with feature package DA.

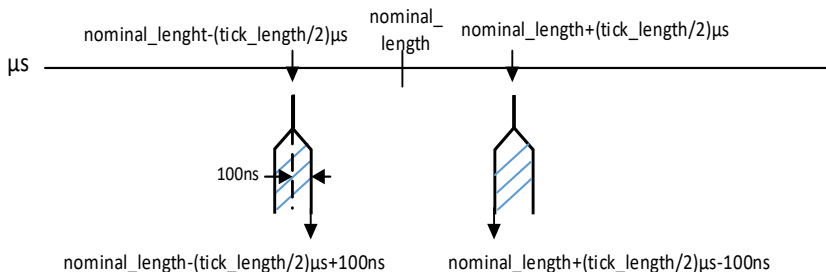
Figure 18 SENT Standard Tolerance

The length of a nibble in the SENT protocol determines the value of this nibble. For each value this length can vary, but it has to be at least inside a given range. This range is given by the SENT standard.

- The lower border is $\text{nominal_value} - (\text{tick_length}/2) \mu\text{s} + 100 \text{ ns}$
- The upper border is $\text{nominal_value} + (\text{tick_length}/2) \mu\text{s} - 100 \text{ ns}$.

In this design step the range is delimited as follows:

Recommendation
