APPLICATION NOTE 3479

# DS2154 – Migrating from Revision A2 to D1

Mar 23, 2005

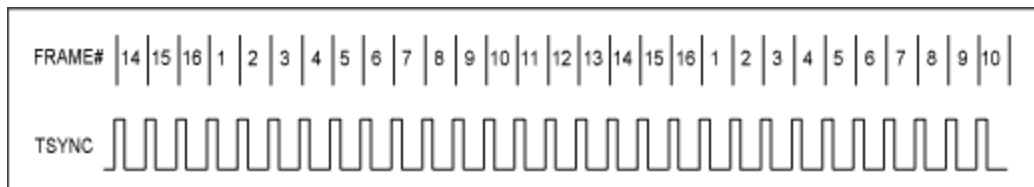
Figure 1. Transmit-side timing between TSYNC and frame number.

In the DS2154 D1 revision, when TSYNC is configured as an input by setting TCR1.0 = 0 (TSIO = 0), the E1 SYNC signal sometimes does not synchronize correctly with the MSB of time slot 0 (TS0).

When replacing the A2 revision of the DS2154 with the D1 revision, most applications will never experience this timing issue. However, if the application experiences this problem, it is recommended to increase the TSYNC delay by 25ns or to widen the TSYNC pulse. For further questions about the operation of the DS2154, please contact the Maxim Telecommunications Applications support team through email: [telecom.support@maximintegrated.com](mailto:telecom.support@maximintegrated.com), or phone: 972-371-6555.
