AVR128DB28/32/48/64

AVR128DB28/32/48/64 Silicon Errata and Data Sheet Clarifications

The AVR128DB28/32/48/64 devices you have received conform functionally to the current device data sheet (www.microchip.com/DS40002247), except for the anomalies described in this document. The errata described in this document will likely be addressed in future revisions of the AVR128DB28/32/48/64 devices.

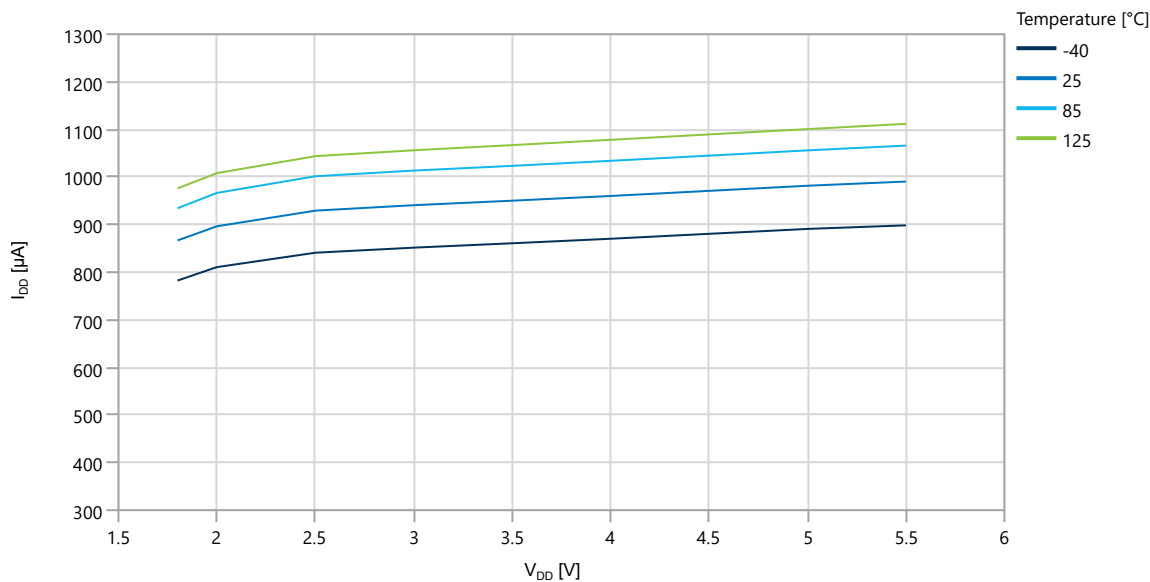
Figure 3-1. I_{DD} Over V_{DD} and Temperature With IRSEL = 0

Note: This plot is only valid for revision A5 and later.

Unless otherwise noted, the typical graphs are valid for the following conditions:

- Output load: 50 pF||3 kΩ
- Input common-mode voltage at $V_{DD}/2$
- Internal voltage follower mode
- IRSEL = 0

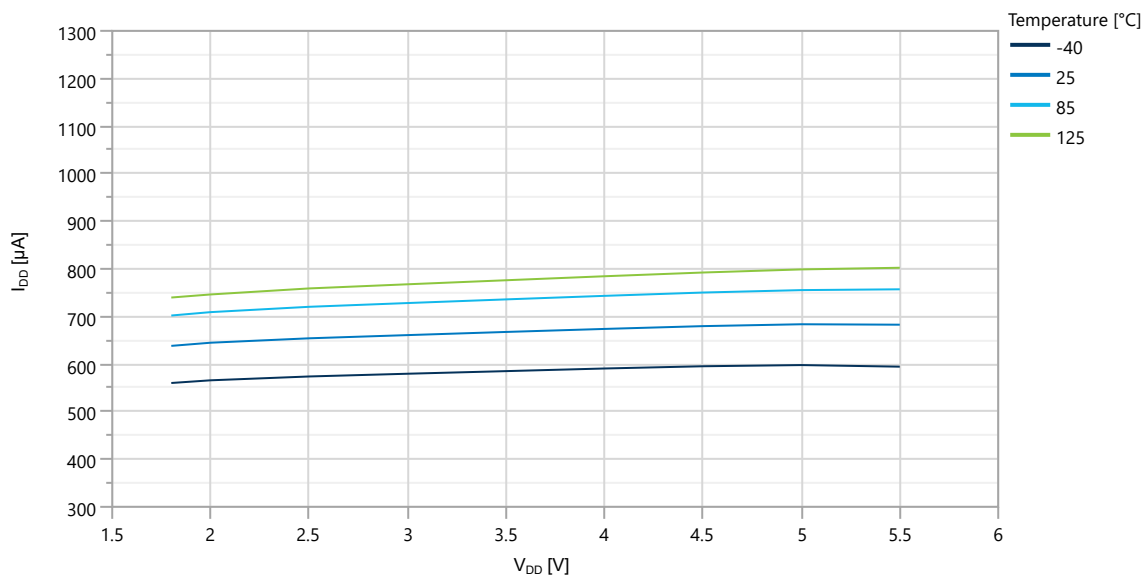
Figure 3-2. I_{DD} Over V_{DD} and Temperature With IRSEL = 1

Note: This plot is only valid for revision A5 and later.

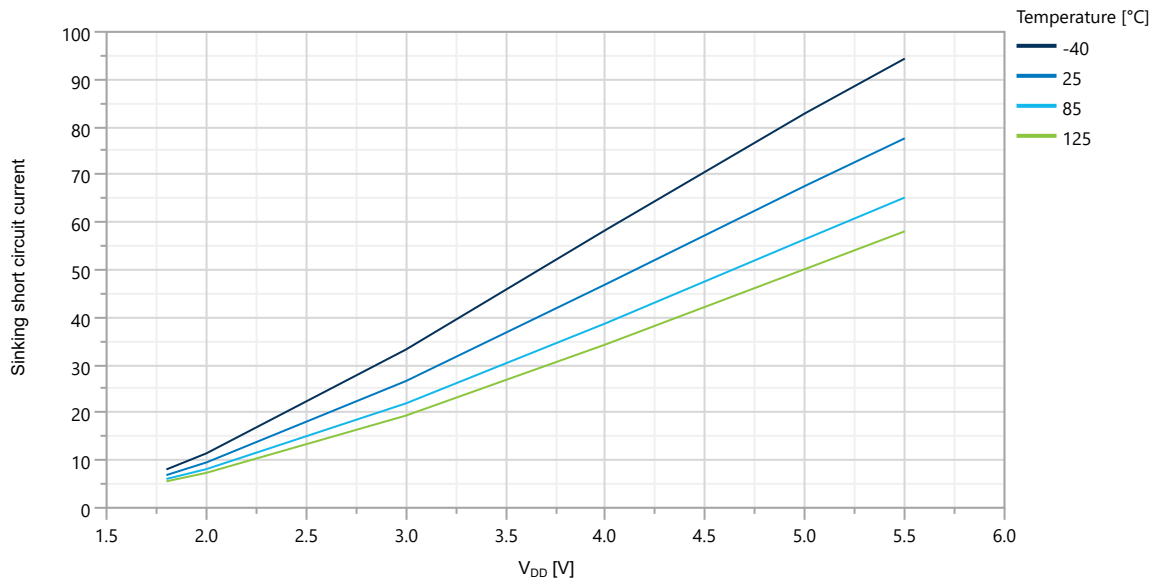
Figure 3-3. Output Sinking Short Circuit Current Over V_{DD} and Temperature

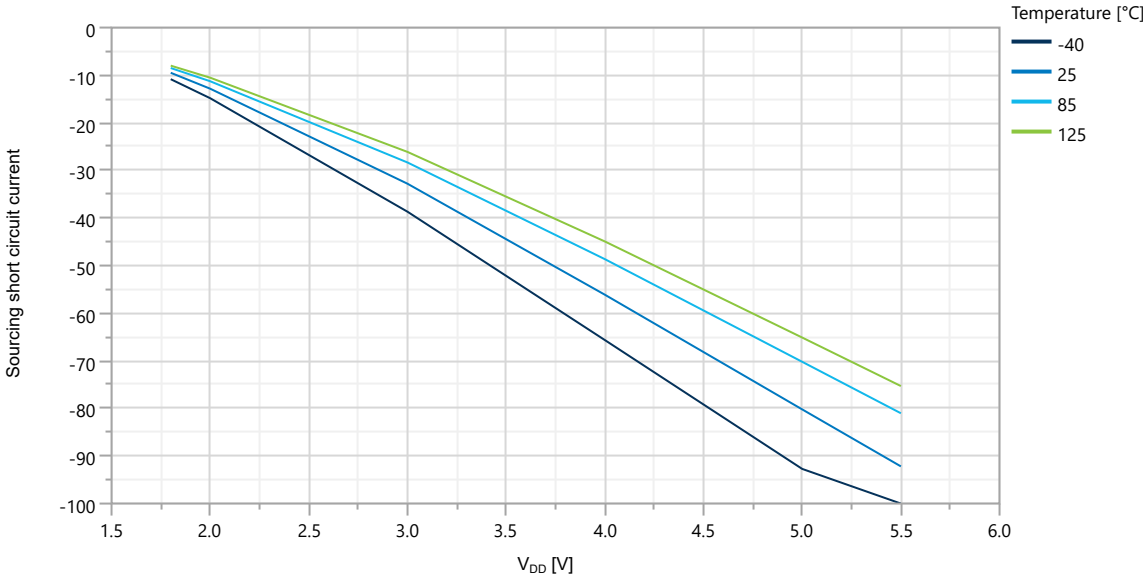
Figure 3-4. Output Sourcing Short Circuit Current Over V_{DD} and Temperature

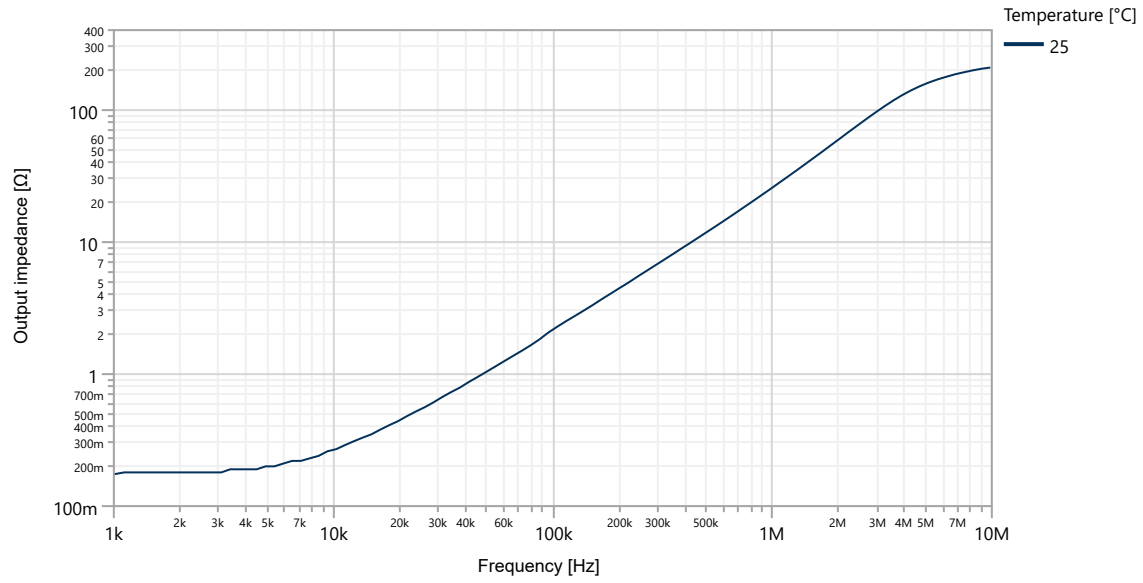
Figure 3-5. Output Impedance Over Frequency at 3V and 25°C

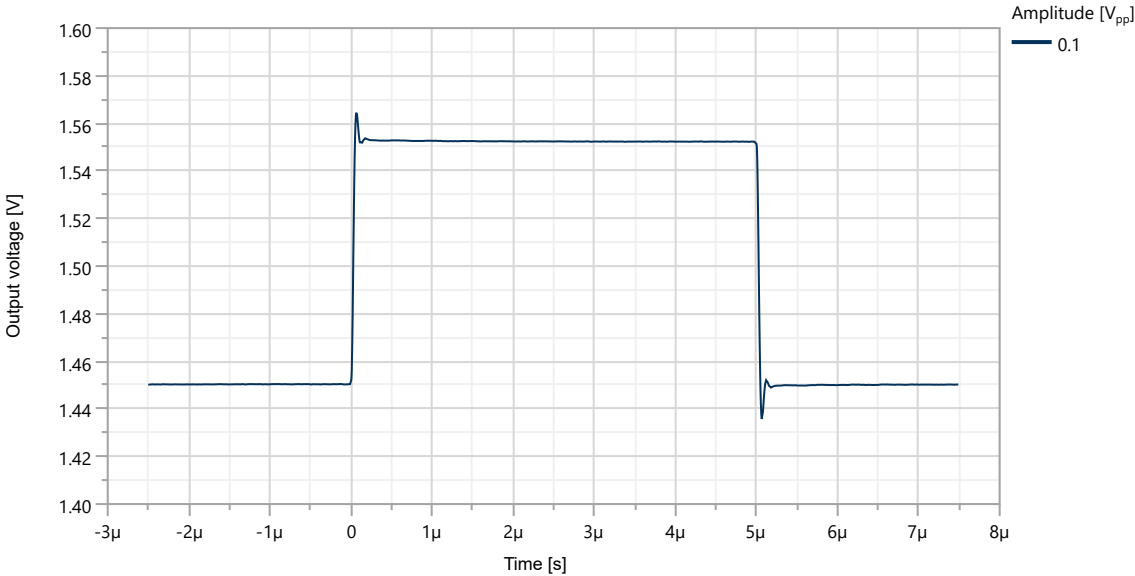
Figure 3-6. Small-signal Non-Inverting Pulse Response at 3V V_{DD} Using 10 kΩ Load

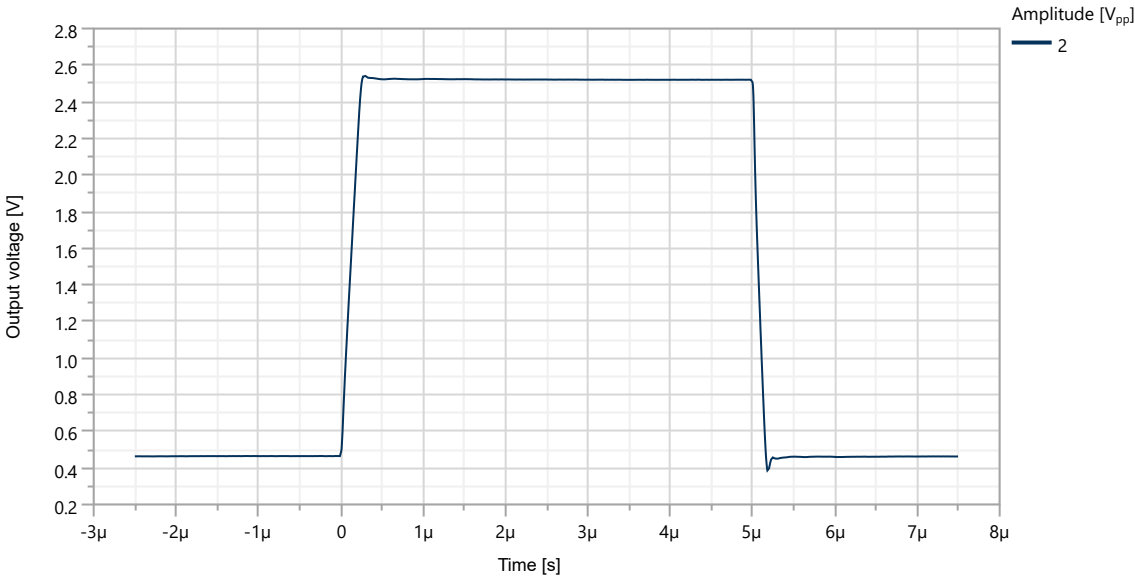
Figure 3-7. Large-Signal Non-Inverting Pulse Response at 3V V_{DD} Using 10 kΩ Load
